**OIL
FILTRATION
SYSTEMS®**

Topic: Varnish Contamination In Large Hydraulic Shear

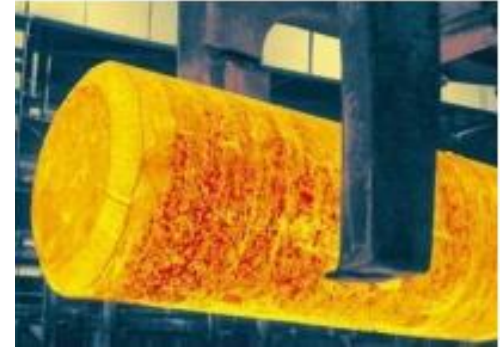
Operators of a large Hydraulic Shear noticed elevated temperatures and a discoloration of the oil in their 2,500-gallon hydraulic oil system. This prompted them to conduct oil analysis, and the lab results revealed an elevated varnish potential number of MPC 49. If left untreated, the operators were worried that varnish would eventually cause premature failure of the large Hydraulic Shear, requiring costly repairs and down-time

To effectively mitigate the varnish contamination in the hydraulic oil, the plant to implement a 10 GPM Varnish Removal System utilizing Granular Adsorbent Media and High Efficiency Beta>1000 Filter Elements to re-circulate the reservoir in a kidney-loop configuration, continuously removing impurities as the hydraulics of the Shear were actuated.

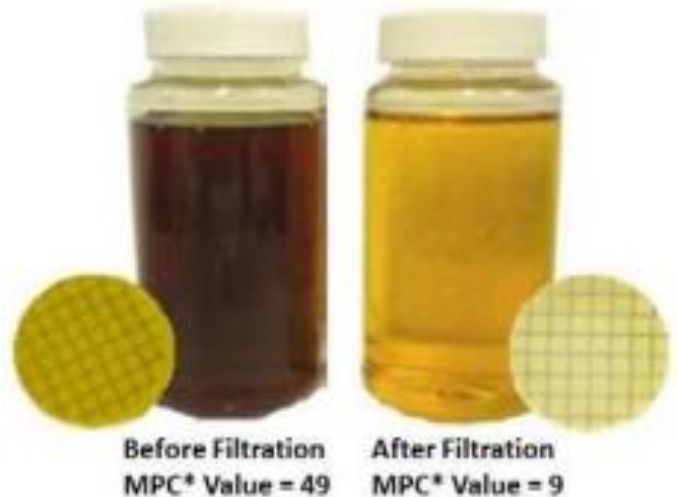
Varnish Removal Analysis (Membrane Patch Colorimetry*)

The starting varnish content in the oil was MPC 49. After approximately 6 weeks of run-time, the varnish potential dropped significantly to MPC 9
