September 28, 2016
Location: Southern Australia

CASE STUDY

Solar Titan 250 Gearbox Failure of Large Gas Turbine Generator

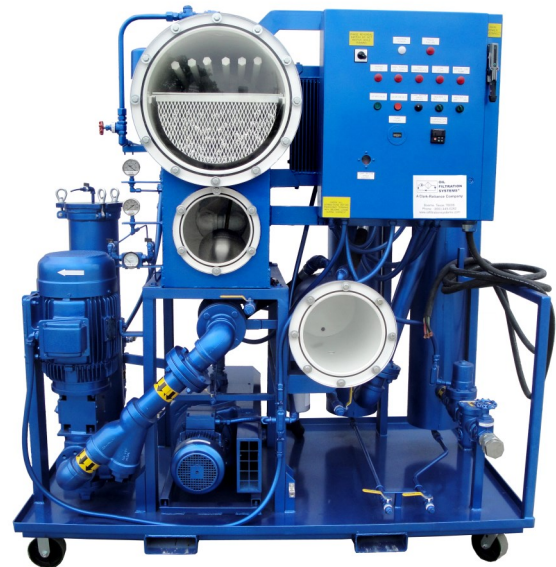
Representative 50 GPM VDOPS

A small transfer pump equipped with a 3-Micron filter element was placed on the gearbox to pump the lube oil into the main tank. A 50 GPM Vacuum Dehydration Oil Purification System (VDOPS) from Oil Filtration Systems®, equipped with a high efficiency 5-Micron Beta >1000 filter element, was placed on the main tank to re-circulate the oil for 48 hours, dropping the particle count from ISO 24/23/20 to ISO 9/8/7. A “flush” of the lube oil piping was then performed, dislodging more debris and returning it to the reservoir, resulting in a spike of particle counts in the oil. The VDOPS continued to re-circulate on the main tank for another 24-hours, and ultimately achieved a final particle count of ISO 10/9/8 (or NAS Class 0), far exceeding the required cleanliness specification of ISO 16/14/11 (NAS 5).

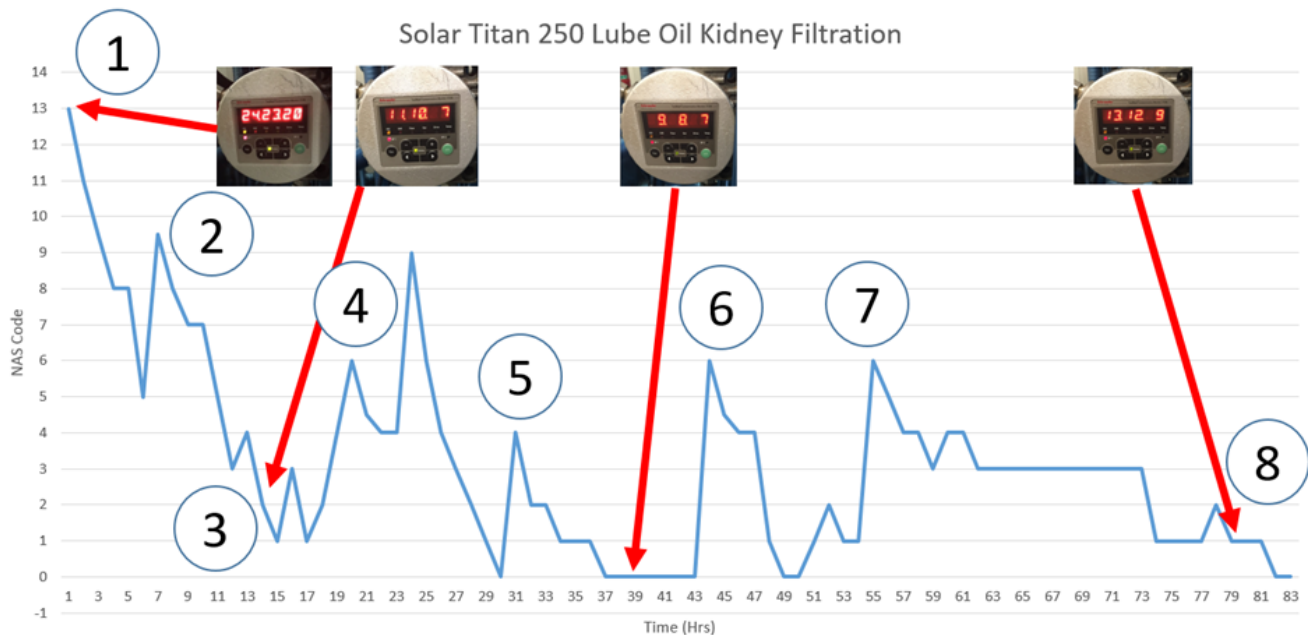
The starting particulate content in the oil was ISO 24/23/20 (NAS 12). After a few days of recirculation, the particulate contamination dropped significantly to ISO 10/9/8 (NAS 0), which is over **4000x cleaner** than where it started.

1. Unit Start -ISO 4406: 24/23/20 (NAS 13)
2. Onboard Tank Emptied Into Reservoir
3. Kidney Filtration Achieved ISO 4406: 11/10/7 (~NAS 1) in 15 hours
4. Lube Oil Tank Pump Started
5. Flow Pat Direction Changed
6. Filtration Stopped Overnight –Cold Start and Settled Contaminant Spike
7. Turbine Start
8. Turbine Operational –ISO 4406: 10/9/8 at Disconnect (NAS 0)
